Failure of a Cut Slope and Deterioration of Shear Strength due to Weathering

Mochizuki, Akitoshi; Ma, Xianfeng; Sockheang,
Sreng

Mochizuki, Akitoshi ...[et al]. Failure of a Cut Slope and Deterioration of Shear Strength due to Weathering. Proceeding of TC302 Symposium Osaka 2011 : International Symposium on Backwards Problem in Geotechnical Engineering and Monitoring of G ...

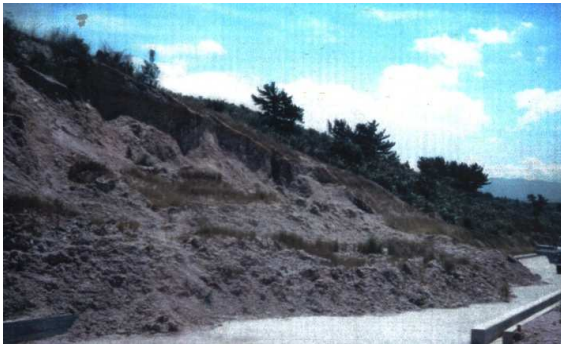
Fig.1 Picture of the slope failure

In this paper, a failure of a cut slope, which was constructed as part of a new local road through hills constituted of stiff clay of the Osaka Marine Clay group in the southern part of Osaka, Japan is investigated. The slope's gradient was 1:1 and had a berm at a height of 10m measuring 50m length for a new local road. Four months after cutting of the slope, in early spring, a 25m wide portion of

the slope collapsed. Fig.1 shows a photo at the site of the slope failure. Site investigations using sounding method and laboratory tests were carried out in order to study the cause of this failure.

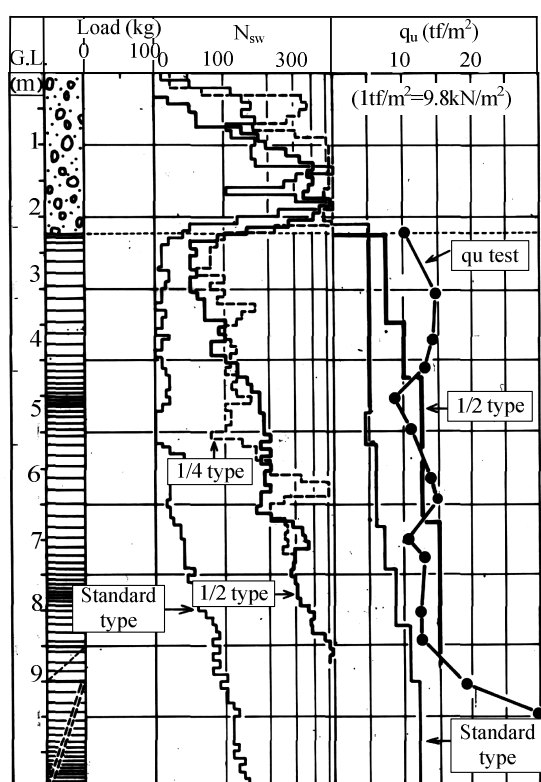
Fig. 4 Drilling log at point No.9

The profile of borehole No.9, whose location is shown in Fig.3, is presented in Fig.4 as a representative soil profile of the hill. A layer, measuring almost 2m thick, of dense white-brown gravel with maximum particle size of less than 50mm covers the *Ma-8 stiff clay layer*, which is approximately 6m thick. This clay is grey-blue when fresh but changes to a white-brown color shortly after drying and also develops cracks and flakes propagating at the surface of the slope. Alternately there are thin silty-clay layers with a small amount of fine sand, and thin sandy-silt layers underlie the stiff clay. Although vegetation was planted, grass growth was poor due to the presence of sulfur in the clay.

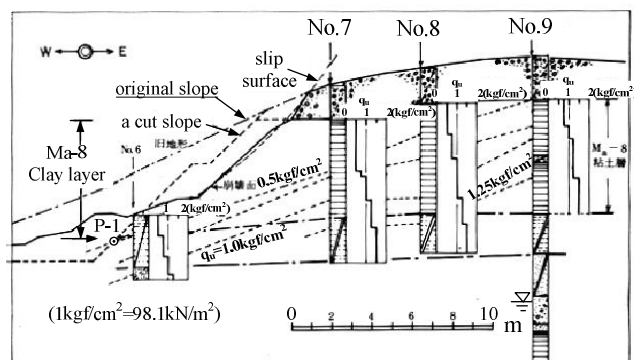
Fig. 6 Cross section of the slope and strength distribution

Fig.6 shows a cross-section through the central part of the landslide and the strength distribution of the sounding tests. Broken lines with dots separate zones with an increment of 0.25 kgf/cm^2 ($\div 25\text{ kN/m}^2$) of q_u . These show values observed by the sounding tests. It is found that strength contours in the clay layers are almost parallel to the original topography, though the Ma-8 clay layer is located almost horizontally, namely, the parallel distribution of strength to the original topography is expected to be. It is supposed that some degree of weathering must have taken place as the decrease of the strength which should occur perpendicularly to the original hill surface.

The slip surface observed was to pass through *P-1* crossing the lower boundary of the Ma-8 Clay layer, coming up towards the top of the slope as shown by a dotted line in Fig.4.

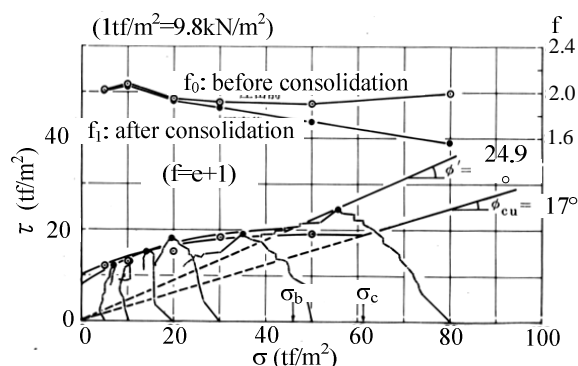
Fig.9 Relationships of shear stress to vertical stress and strength curves: Test-A (CU-test)

Table 2 shows the testing program, and procedures followed for the JGS guide line on the CU-test using the direct shear apparatus (Takada, 1993). Fig.9 shows the effective stress path of tests obtained in terms of shear stress, τ , and vertical effective stress, σ' . The strength parameters, c' and ϕ' , are obtained from a strength envelope connecting τ_{max} and σ' on stress paths. The envelope line is divided into two parts at a stress of σ'_b , where the stress σ'_b is the stress representing influence of consolidation yield stress (Mochizuki, 1996). It is known that the envelope generally shows an upward curve for a stress range less than σ'_b , whereas a higher strength stress range than σ'_b gives a straight line which passes through the origin of the graph.

Hence, the strength parameters, c_{cu} and ϕ_{cu} , are obtained from an envelope passing through stresses characterized by the maximum shear stress, τ_{max} , and the consolidation stresses of soil, σ'_0 . The envelope for CU-condition is also divided into two parts at a stress of σ'_c , showing an upward curve for $\sigma > \sigma'_c$, and a straight line for $\sigma'_c > \sigma$. Here, stress, σ'_c , is named as 'yield stress from a CU-shear test', and is regarded as being equivalent to the consolidation yield stress, σ'_y . This test denoted as Test-A, and the strength obtained is termed as Strength-A, which will be dealt with as an index strength for Strength-B to E, which will be shown in the following section. 2.4
